## Amaryllis

*-75 year old Brigham Sharpie restored by David Hamilton and racing again.*

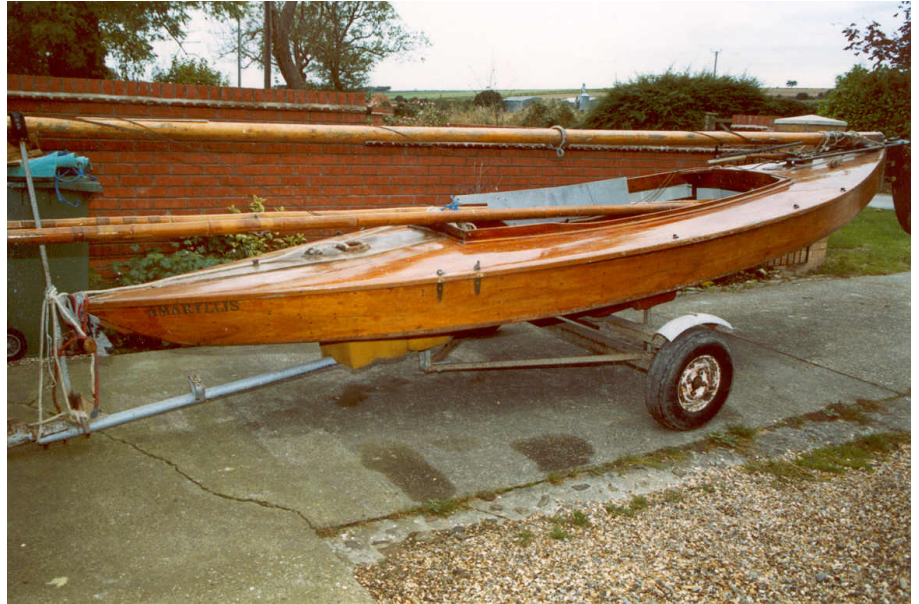
Amaryllis in October 2002 before restoration

The main problem areas were the fore and aft deck, and the floor boards. The centre deck panels were the worst and they warped badly due to humidity and temperature changes. The mahogany panels expand and contract across the grain quite significantly when exposed to the weather. The resultant cracks had been subsequently filled with epoxy and the material had then warped when exposed to humidity. I initially considered replacing the whole deck with teak strips but finally decided that at least 70% of the original decking was still in good condition, and the centre panels could more easily be replaced. It then became my primary objective to preserve as much of the original construction as possible.

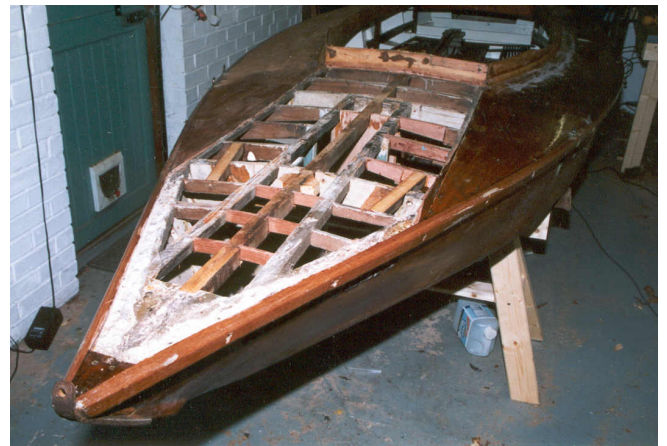
Removal of the deck panels was a relatively easy task. Walter had used brass wood screws throughout in the construction, no nails anywhere, and these were easily removed. I endeavoured to remove the old panels intact as I had in mind a use for them later. Once opened up it was evident that the frames were in better condition than I had hoped. Apart from a few small areas where the wood had rotted, mainly around the mast step, there were only a few loose frames where the glue had deteriorated.

The foredeck has been removed to allow access to the frames and hull.

Old joints were cleaned up and re-glued using either Balcotan or West System Epoxy. New frame parts were made from meranti strip, I reinforced the frames under the mast step and added 1/2" plywood supports between the deck and the keel to carry the downward thrust of the mast. One of the worst jobs was the removal of the old and dehydrated white lead putty which had been used to caulk the joints between the deck panels and the frames.

The remaining decking was generally in good condition, but there were several large cracks and one area where the deck was buckled. I decided that the best solution was to cut out the damaged areas and inset a "patch". Over the 70 odd years there have been many areas of damage which have been repaired this way, and the "patchwork quilt" effect is an attractive feature of the boat. I evolved a method of using a router with a V-cutter to excise the offending areas and create a 45degree scarf joint. Simple cracks were routed out with a single straight cut. The old deck panels were used as a source of material for the patches.

All the new timber framework was given a good coating of Deks Olje D1 as a preservative and the new deck panels were fitted. The panels were set in and caulked with the acrylic mastic sold as window frame sealant and secured with brass screws. I tried to salvage and re-use as many of the original screws as possible, although many had been sanded down until there was almost no head left.

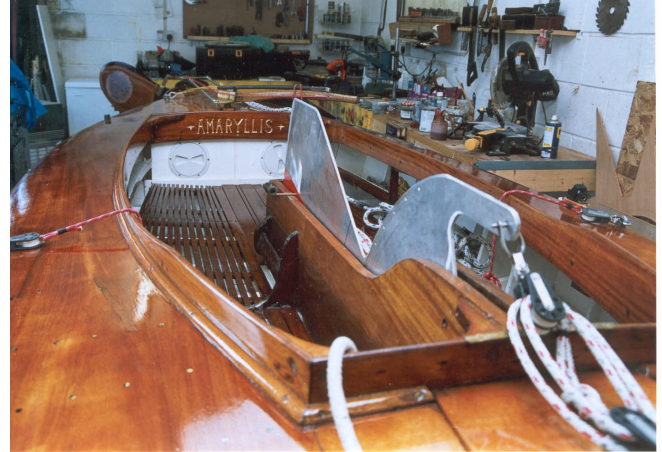
The cockpit view after restoration

As built she was originally open from stem to stern. I was initially reluctant to change this but I was persuaded that in the event of a capsize I would have a ton of water to bail out. In view of my relative inexperience as a skipper and Amaryllis' reputation as a "lively" craft I took sound advice and fitted bulkheads. These were made from Robbins Elite and incorporated two screw-in hatch covers in each. I fitted and sealed these bulkheads in position before fitting the new deck panels. In the event they proved their worth first time out when she capsized while running down wind. An interesting experience, I felt somewhat miffed at being dunked after spending two months restoring the boat!
